ISSN 1944-9836

ASSOCIATION OF STATE
DAM SAFETY OFFICIALS

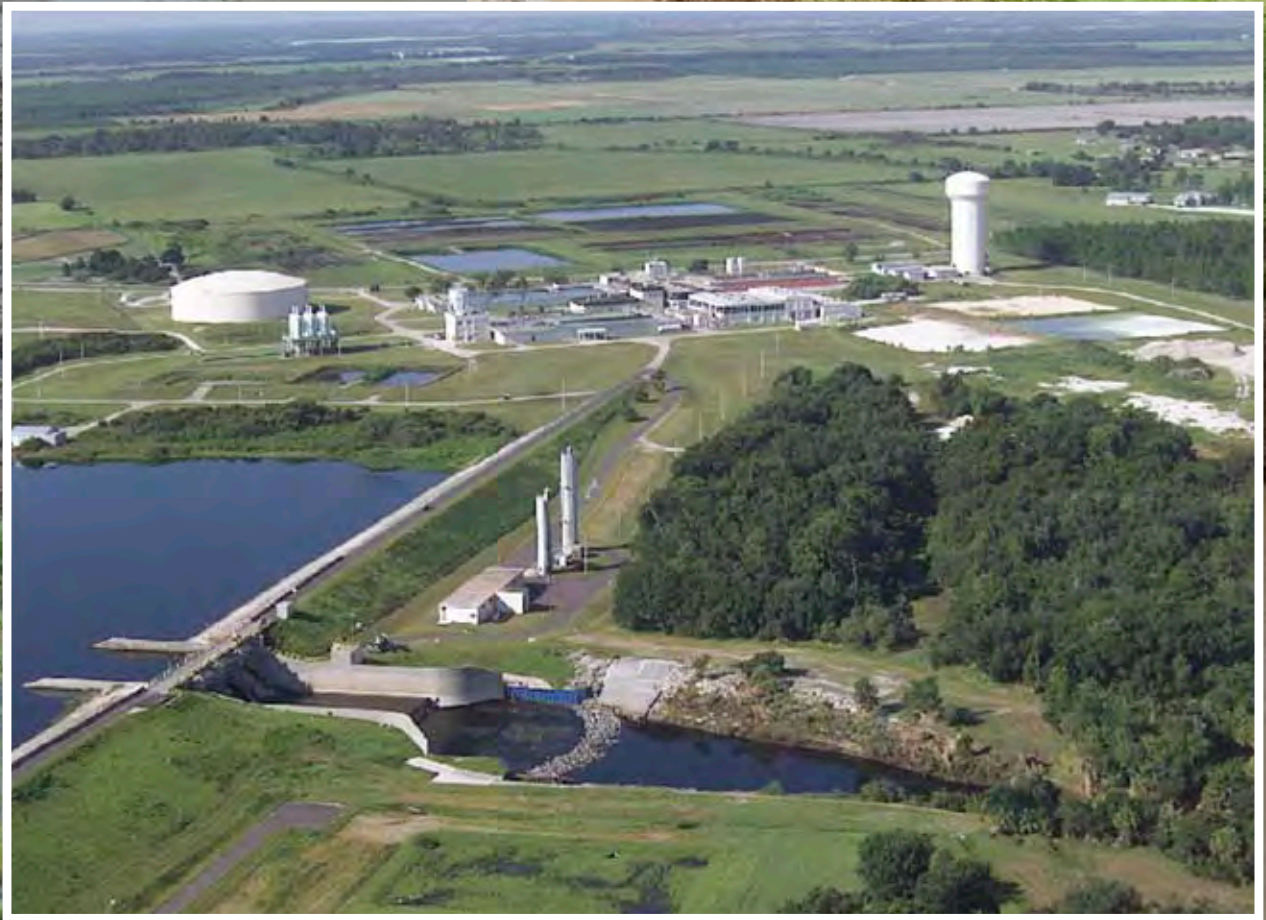
VOLUME 13 | ISSUE 1 | 2015

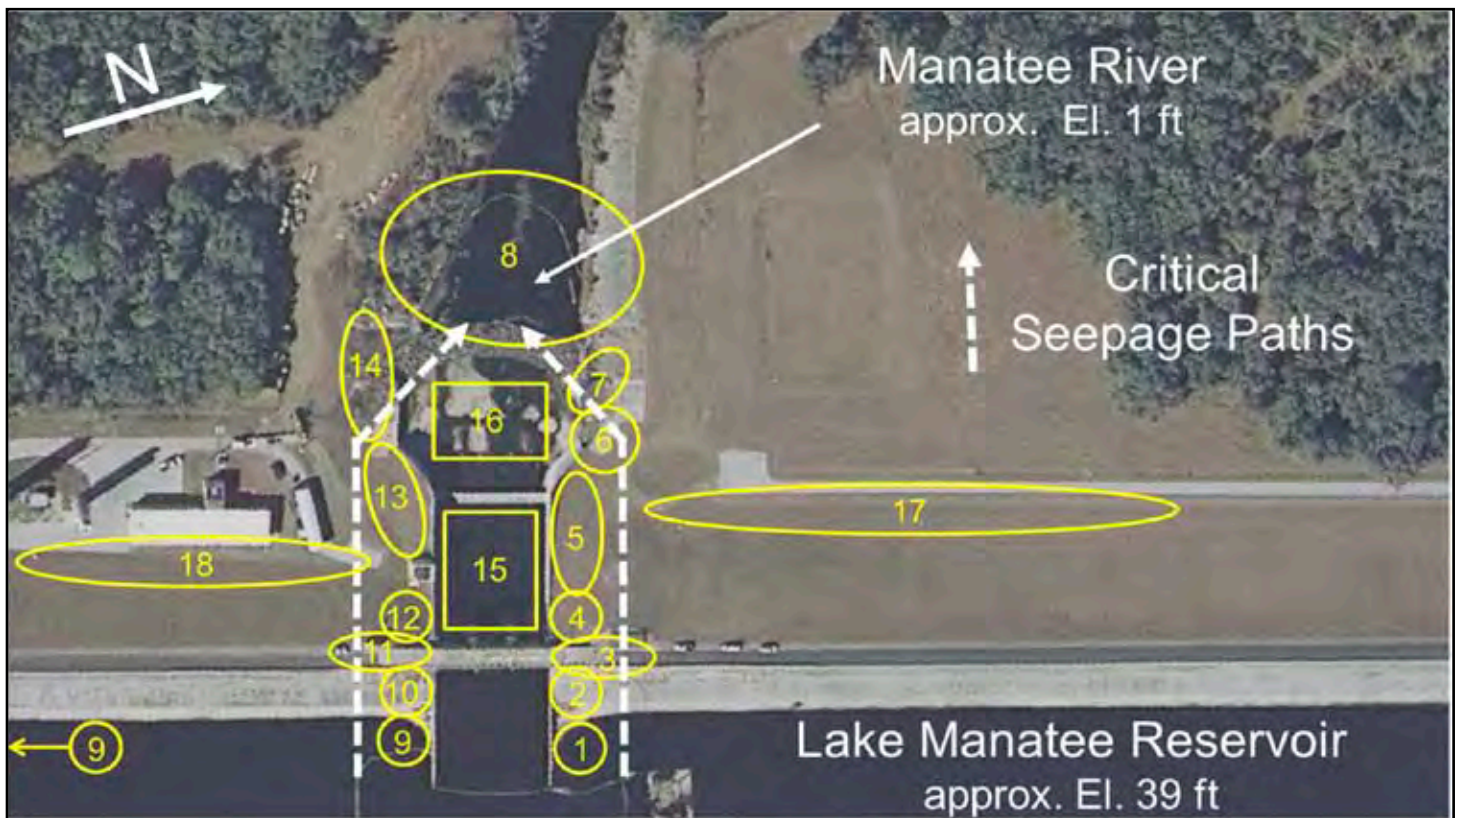
FIGURE 5: CRITICAL SEEPAGE PATHS AND LOCATIONS OF SIGNIFICANT HISTORICAL OBSERVATIONS

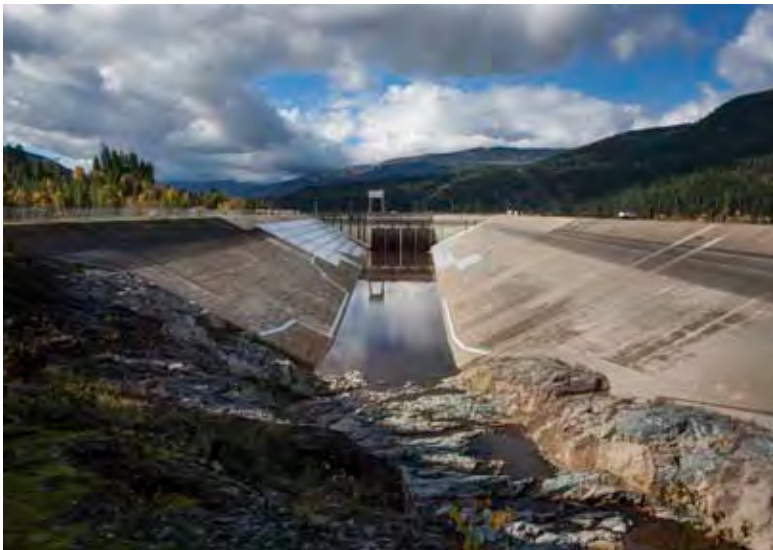
KOOTENAY – CANADA 2014
 Rehabilitation of a hydropower canal forebay, >103,000 ft²,
 with exposed PVC geomembrane on joints and canal face

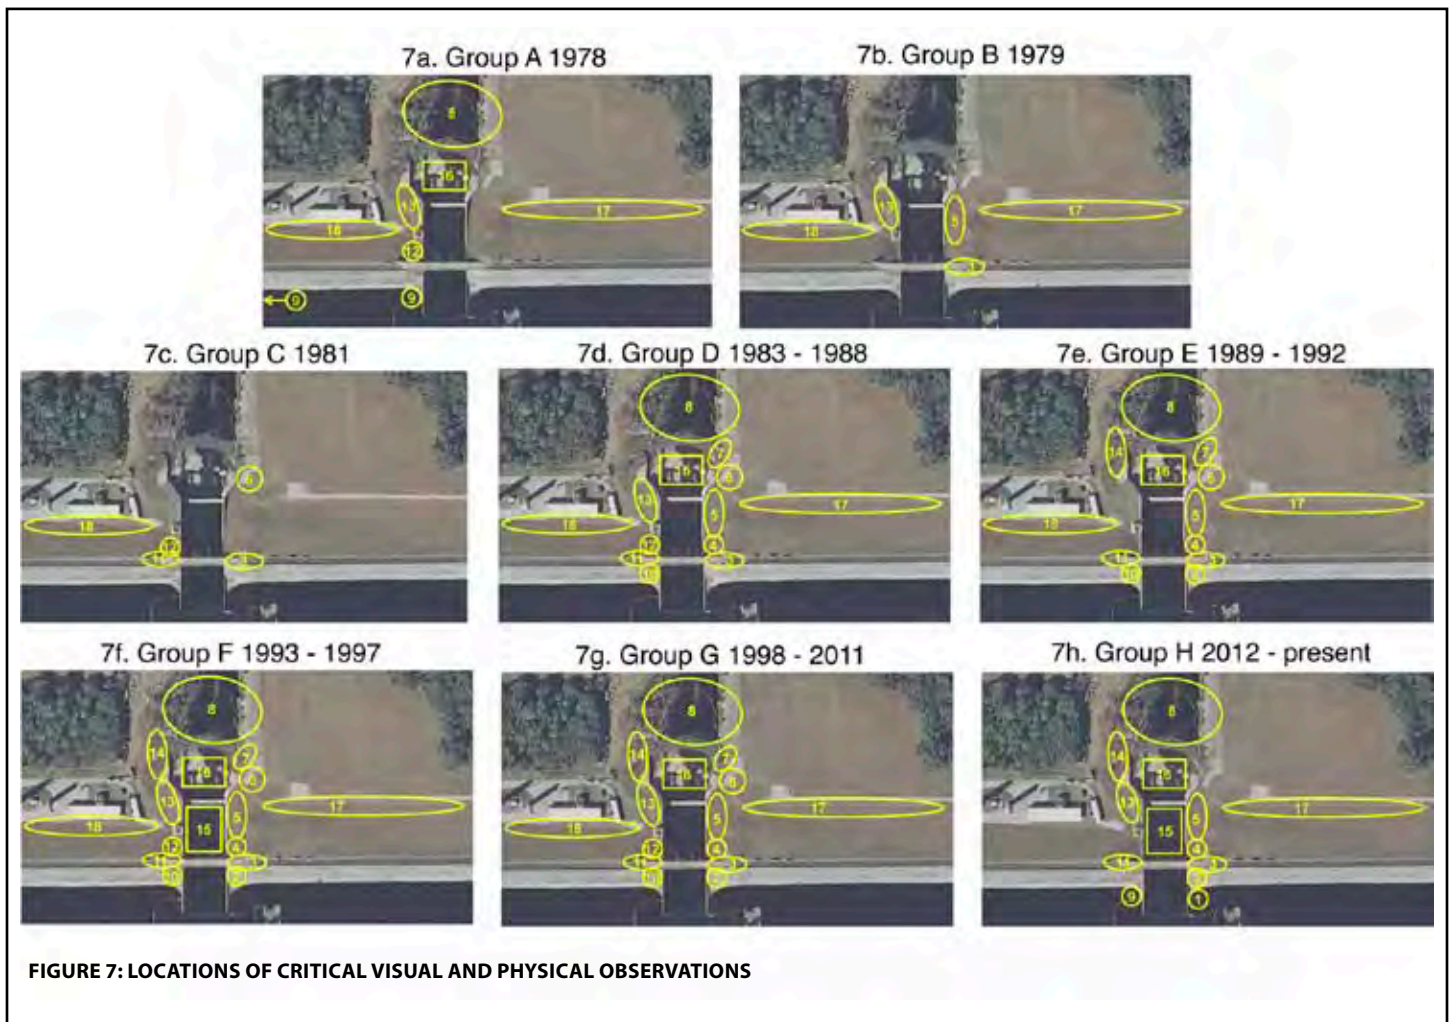
- d) a 3 ft diameter by 2 ft deep sinkhole immediately adjacent to the south training wall and directly above the existing toe drain outfall;
- e) loss of embankment material under the concrete stairway between the bridge deck and the southern downstream training wall;

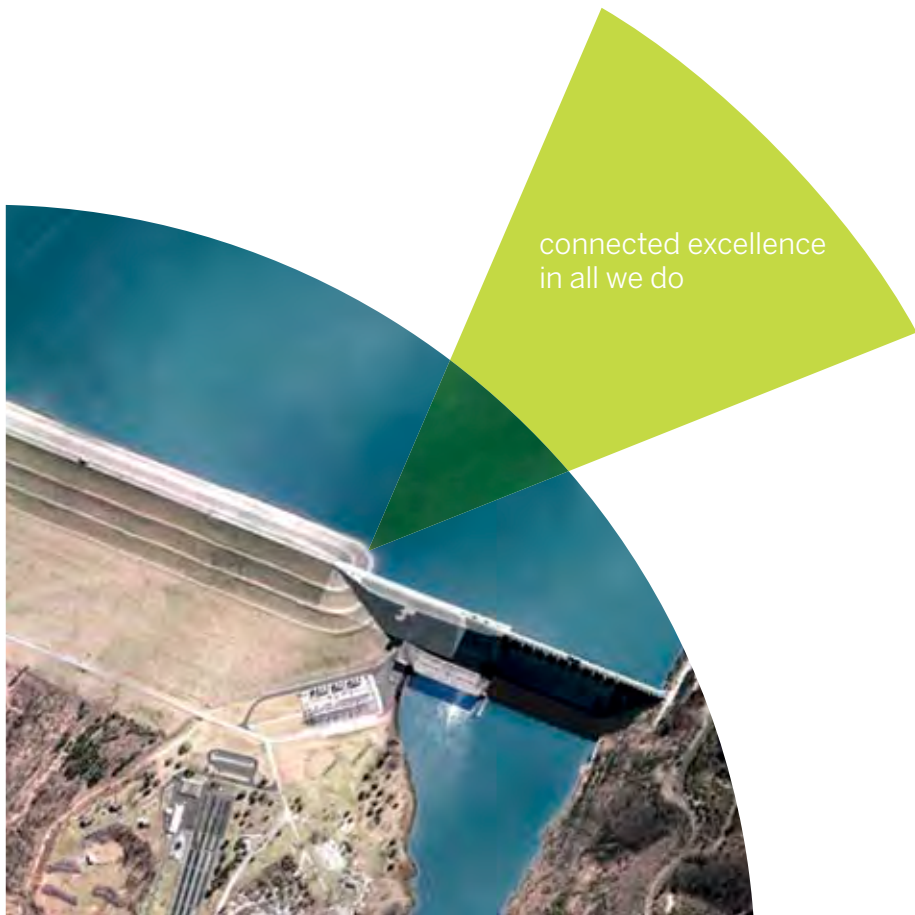
connected excellence
in all we do

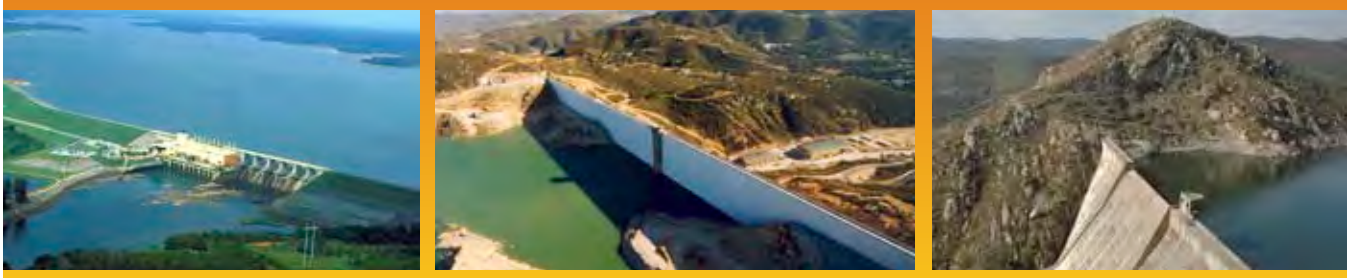
DAM ENGINEERING SERVICES

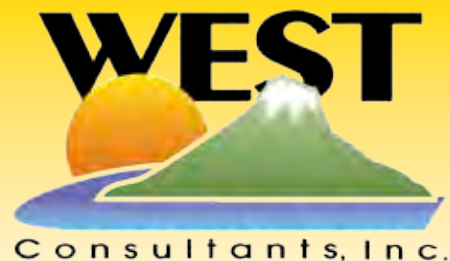
Water • Environmental • Sedimentation • Technology

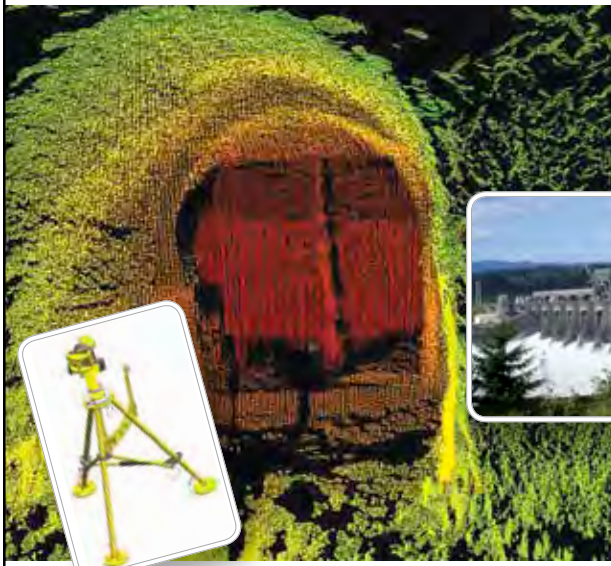
New **QuickStitch** Software: Registering scans together has *never* been easier!

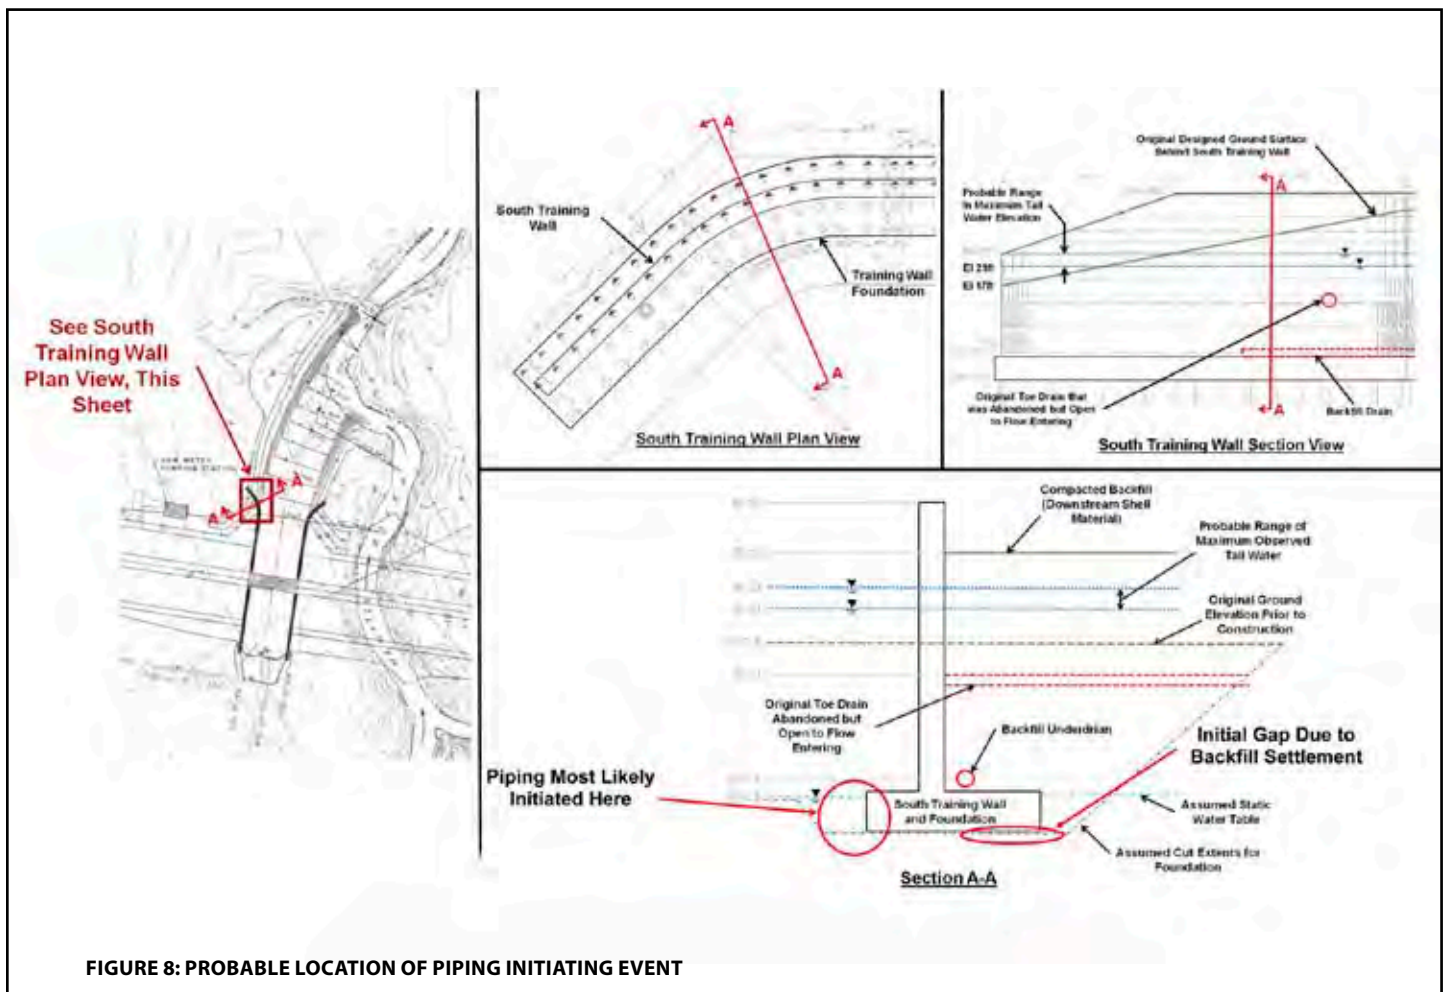
FIGURE 8: PROBABLE LOCATION OF PIPING INITIATING EVENT
